WRDC-TR-89-4112

COMPUTER TOMOGRAPHY OF ELECTRONICS

Richard H. Bossi
Robert J. Kruse
Benjamin W. Knutson

Interim Report For Period August 1988 - May 1989

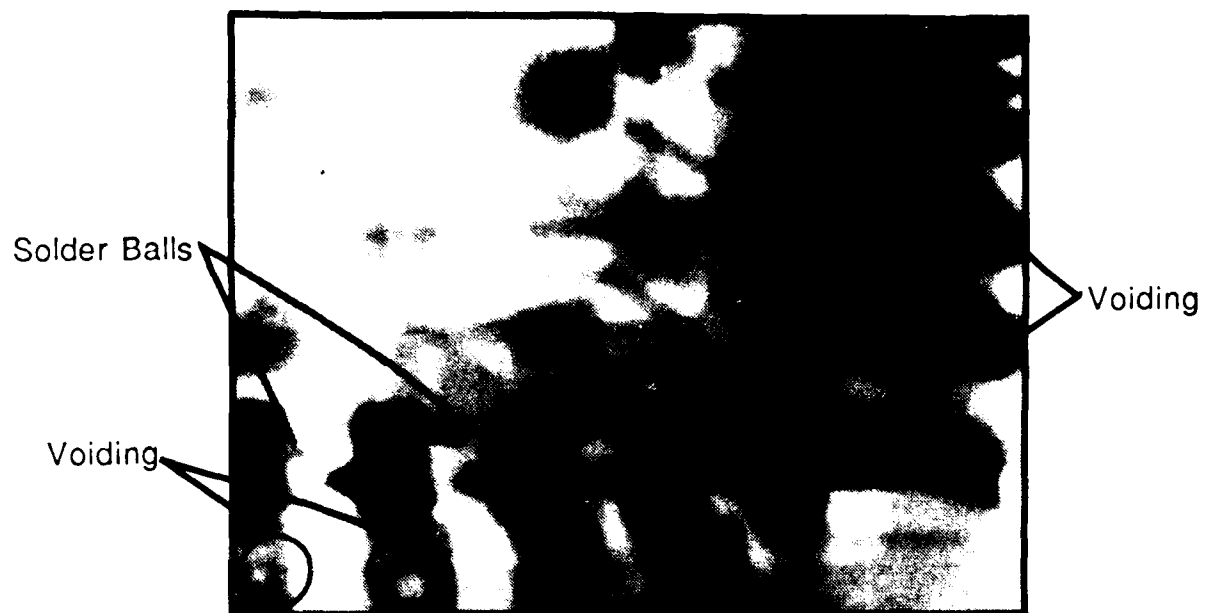
Figure 3.2-14 Radiograph of a portion of the Figure 3.2-11 board from System G

The CIC board was imaged by System G and a radiograph is shown in Figure 3.2-14. The image shows the superposition of the solder locations on the front and back sides of the board. Although there is major confusion when inspecting for defects, voids in the solder in the range of 0.15 to 0.25 mm (0.006 to 0.010 inches) are readily visible.
